High voltage ELD (Electronic Leak Detection) equipment functionality

The purpose of the test was to understand the potential of determining the defects on waterproofing for different types of flat roofs and under different conditions using the high voltage ELD inspection equipment.

Test equipment used for the test: "DRY ROOF PRO" device produced by the company Buckleys (UVRAL) Ltd.

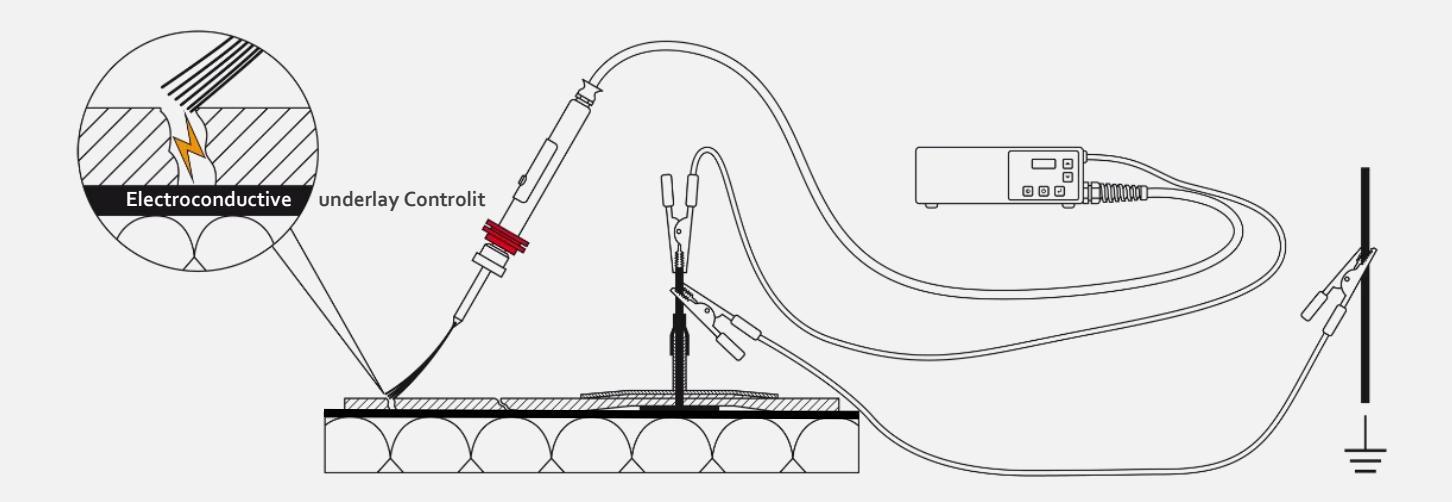
High Voltage (ELD) Test Method with Controlit underlay - testing principle

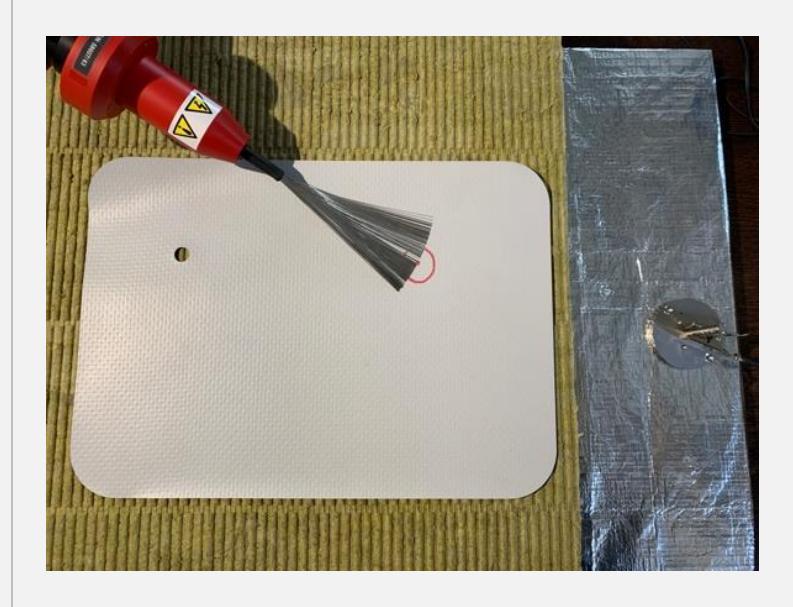
1. Stone wool in dry conditions

Roof structure:

- Electrically conductive bearing structure (metal or concrete).
- Polythene vapour barrier.
- Dry stone wool thermal insulation.
- Waterproofing membrane.

Test results:

• "DRY ROOF PRO" – the pinhole was not detected.

Description:

The inspection equipment was adjusted in accordance to the manufacturers instructions. The device was connected to the electrically conductive bearing structure. During the inspection over the pinhole there were no visual or audible signals.

Conclusion:

It was not possible to determine the damage.

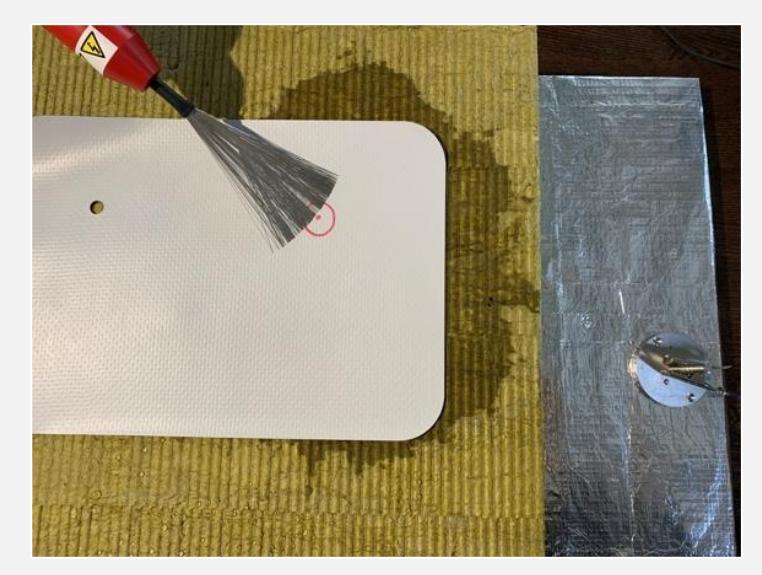
2. Stone wool in wet conditions

Roof structure:

- Electrically conductive bearing structure (metal or concrete).
- Polythene vapour barrier.
- Wet stone wool thermal insulation (moisture traveled to the electrically conductive bearing structure).
- Waterproofing membrane.

Test results:

• "DRY ROOF PRO" – the pinhole was detected. **Description:**

The inspection equipment was adjusted in accordance to the manufacturers instructions. The device was connected to electrically conductive bearing structure. During the inspection over the pinhole there were both visual and audible signals. **Important:** The pinhole was only detected over the wet area. When the pinhole was placed over a dry area, it was not possible to detect it.

Conclusion:

It was possible to determine the damage, but only on conditions that the stone wool under the pinhole is wet.

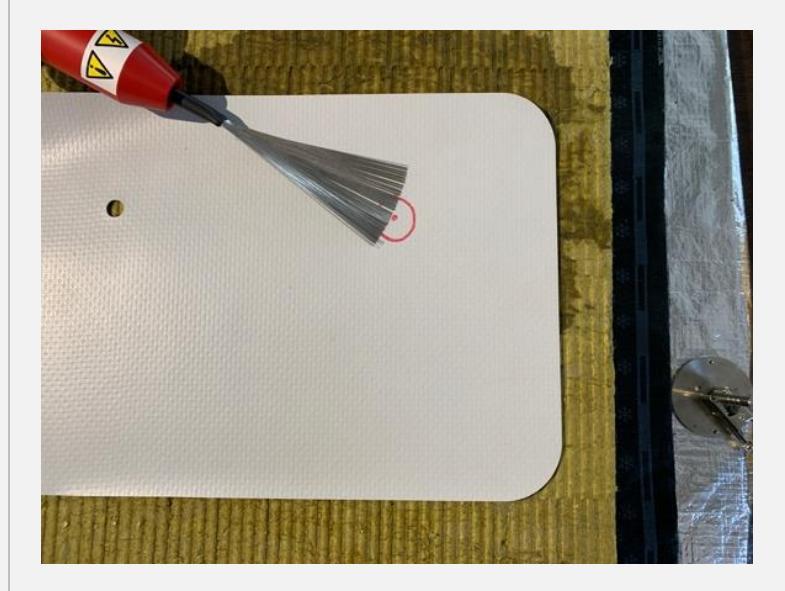
3. Stone wool in wet conditions and the bitumen vapour barrier

Roof structure:

- Electrically conductive bearing structure (metal or concrete).
- Bitumen vapour barrier.
- Wet stone wool thermal insulation (moisture did not travel to the electrically conductive bearing structure, because the bitumen vapour barrier also functions as a waterproofing layer).
- Waterproofing membrane.

Test results:

• "DRY ROOF PRO" – the pinhole was not detected.

Description:

The inspection equipment was adjusted in accordance to the manufacturers instructions. The device was connected to the electrically bearing structure.

During the inspection over the pinhole there were no visual or audible signals.

Conclusion:

It was not possible to determine the damage.

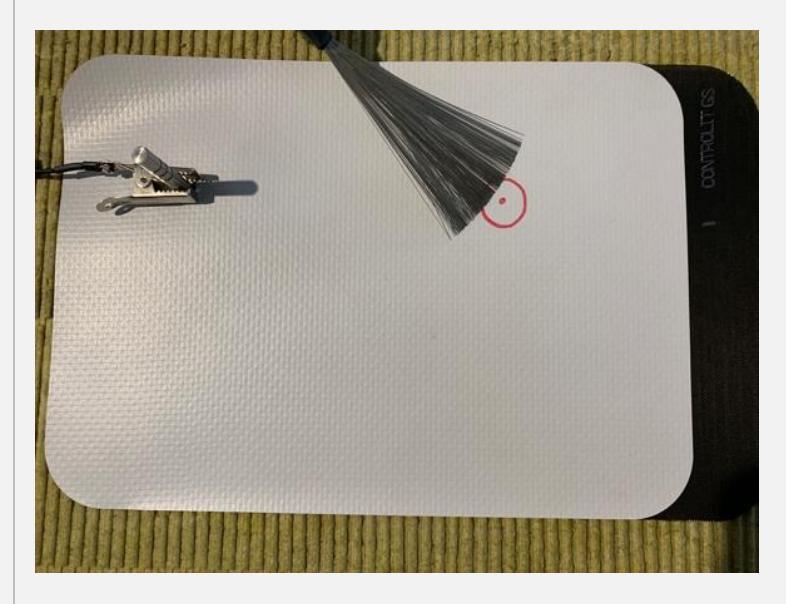
4. Stone wool in dry conditions and the Controlit electrically conductive underlay

Roof structure:

- Electrically conductive bearing structure (metal or concrete).
- Bitumen vapour barrier.
- Dry stone wool thermal insulation.
- Controlit electrically conductive underlay.
- Waterproofing membrane.

Test results:

"DRY ROOF PRO" – the pinhole was detected.

Description:

The inspection equipment was adjusted in accordance to the manufacturers instructions. The device was connected to the Controlit electrically conductive underlay through special connection points. During the inspection over the pinhole there were both visual and audible signals.

Conclusion:

It was possible to determine the damage.

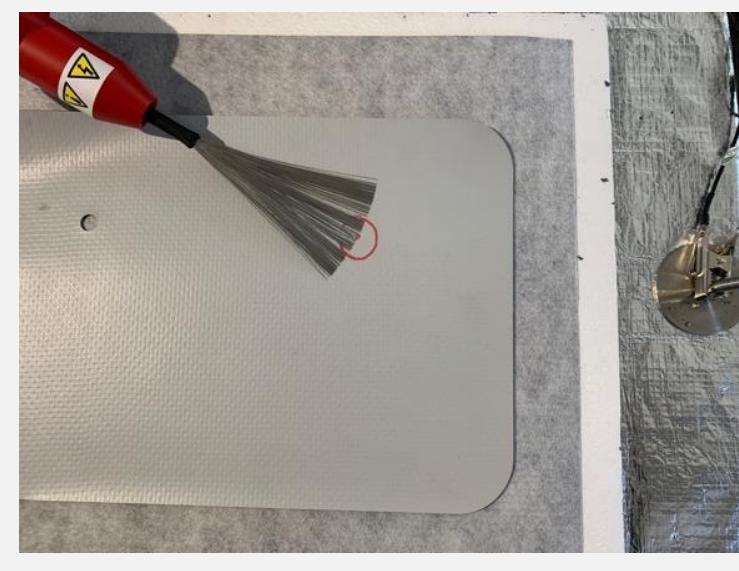
5. EPS in dry conditions

Roof structure:

- Electrically conductive bearing structure (metal or concrete).
- Polythene vapour barrier.
- EPS thermal insulation.
- Dry geotextile.
- Waterproofing membrane.
- Test results:
- "DRY ROOF PRO" the pinhole was not detected. Description:

The inspection equipment was adjusted in accordance to the manufacturers instructions. The device was connected to the electrically bearing structure. During the inspection over the pinhole there were no visual or audible signals.

Conclusion:

It was not possible to determine the damage.

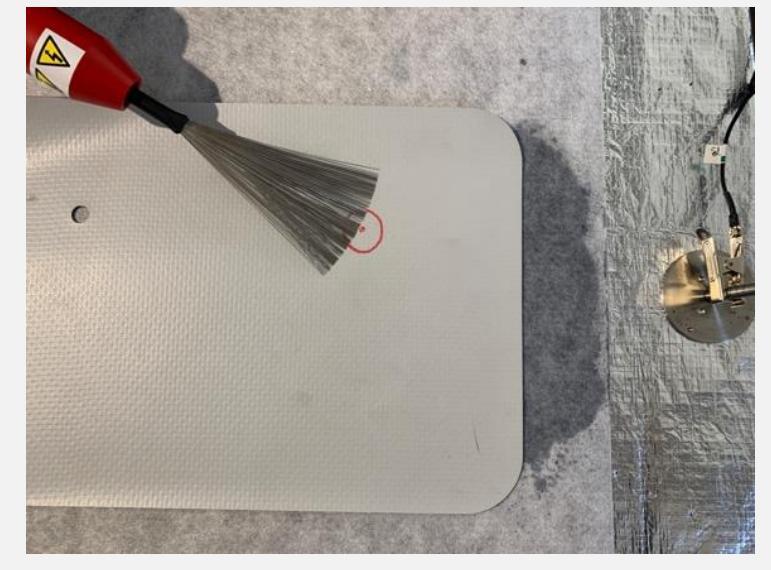
6. EPS in wet conditions

Roof structure:

- Electrically conductive bearing structure (metal or concrete).
- Polythene vapour barrier.
- EPS thermal insulation.
- Wet geotextile (moisture traveled to the electrically conductive bearing structure).
- Waterproofing membrane.

Test results:

• "DRY ROOF PRO" – the pinhole was detected. Description:

The inspection equipment was adjusted in accordance to the manufacturers instructions. The device was connected to the electrically bearing structure. During the inspection over the pinhole there were both visual and audible signals. **Important:** The pinhole was only detected over the wet area. When the pinhole was placed over a dry area, it was not possible to detect it.

Conclusion:

It was possible to determine the damage, but only on the conditions that the geotextile is wet under the pinhole.

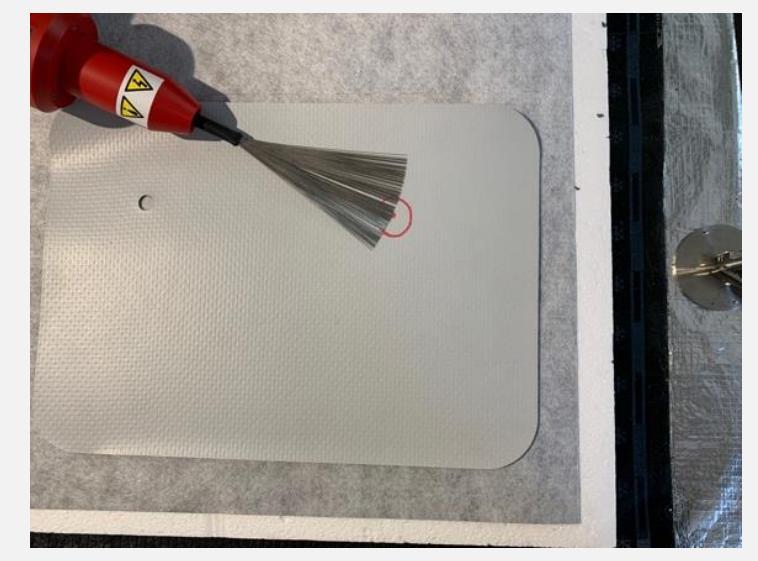
7. EPS in dry conditions and the bitumen vapour barrier

Roof structure:

- Electrically conductive bearing structure (metal or concrete).
- Bitumen vapour barrier.
- EPS thermal insulation.
- Dry geotextile.
- Waterproofing membrane.

Test results:

• "DRY ROOF PRO" – the pinhole was not detected.

Description:

The inspection equipment was adjusted in accordance to the manufacturers instructions. The device was connected to the electrically bearing structure. During the inspection over the pinhole there were no visual or audible signals.

Conclusion:

It was not possible to determine the damage.

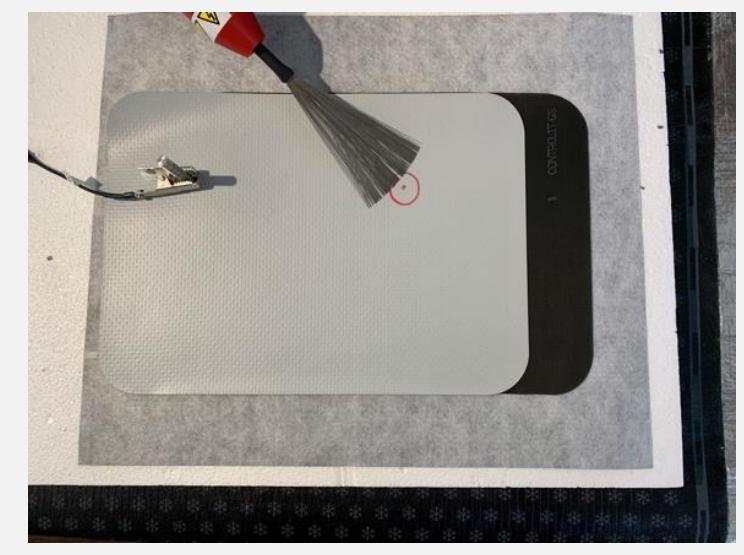
8. EPS in dry conditions and the Controlit electrically conductive underlay

Roof structure:

- Electrically conductive bearing structure (metal or concrete).
- Bitumen vapour barrier.
- EPS thermal insulation.
- Dry geotextile.
- Controlit electrically conductive underlay.
- Waterproofing membrane.

Test results:

• "DRY ROOF PRO" – the pinhole was detected. **Description:**

The inspection equipment was adjusted in accordance to the manufacturers instructions. The device was connected to the Controlit electrically conductive underlay through special connection points. During the inspection over the pinhole there were both visual and audible signals.

Conclusion:

It was possible to determine the damage.

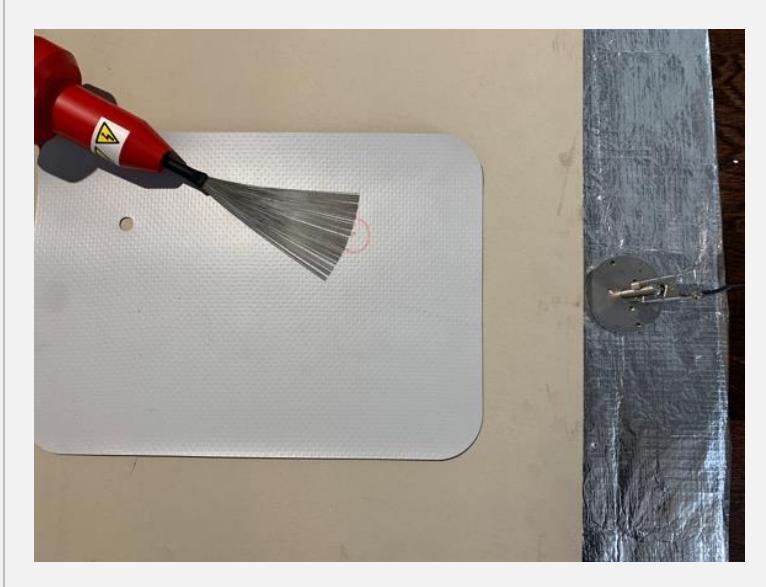
9. PIR without electrically conductive coating

Roof structure:

- Electrically conductive bearing structure (metal or concrete).
- Polythene vapour barrier.
- PIR thermal insulation.
- Waterproofing membrane.

Test results:

"DRY ROOF PRO" – the pinhole was not detected.

Description:

The inspection equipment was adjusted in accordance to the manufacturers instructions. The device was connected to the electrically bearing structure. During the inspection over the pinhole there were no visual or audible signals.

Conclusion:

It was not possible to determine the damage.

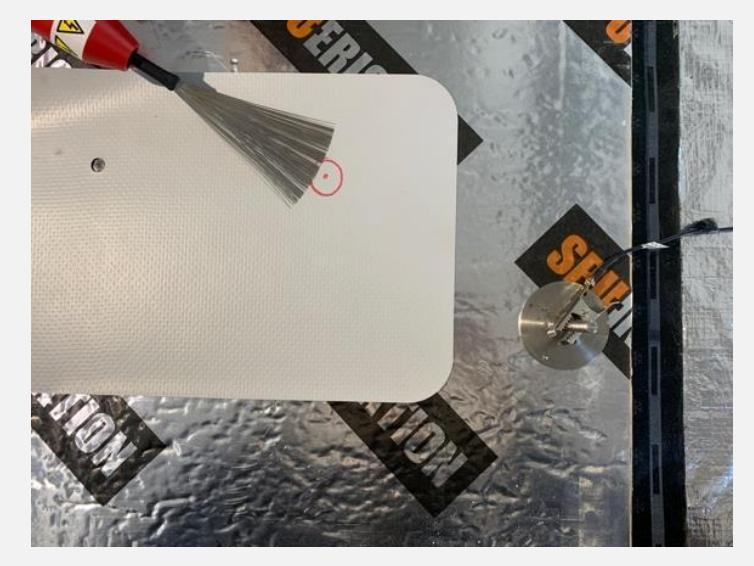
10. PIR with electrically conductive coating (aluminum)

Roof structure:

- Electrically conductive bearing structure (metal or concrete).
- Polythene vapour barrier.
- PIR thermal insulation with aluminum.
- Waterproofing membrane.

Test results:

• "DRY ROOF PRO" – the pinhole was detected. **Description:**

The inspection equipment was adjusted in accordance to the manufacturers instructions. The device was connected to the electrically bearing structure. During the inspection over the pinhole there were both visual and audible signals. **Important:** Aluminum has perfect electrical conductivity, therefore the inspection was possible. However, aluminum tends to oxidize very rapidly under the influence of oxygen and moisture, thus losing its electrical conductivity eventually.

Conclusion:

It was possible to determine the damage. *while the aluminum hasn't oxidized.

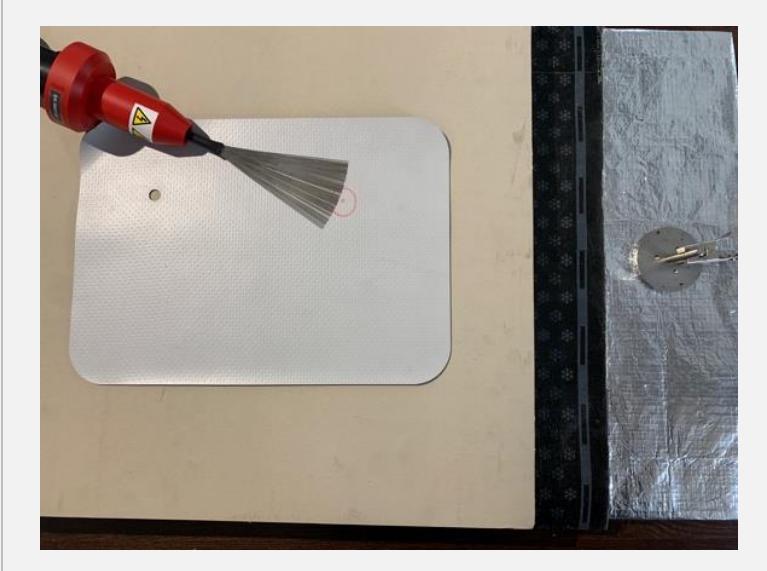
11. PIR without the electrically conductive coating and with the bitumen vapour barrier

Roof structure:

- Electrically conductive bearing structure (metal or concrete).
- Bitumen vapour barrier.
- PIR thermal insulation.
- Waterproofing membrane.

Test results:

• "DRY ROOF PRO" – the pinhole was not detected.

Description:

The inspection equipment was adjusted in accordance to the manufacturers instructions. The device was connected to the electrically bearing structure. During the inspection over the pinhole there were no visual or audible signals. **Conclusion:**

It was not possible to determine the damage.

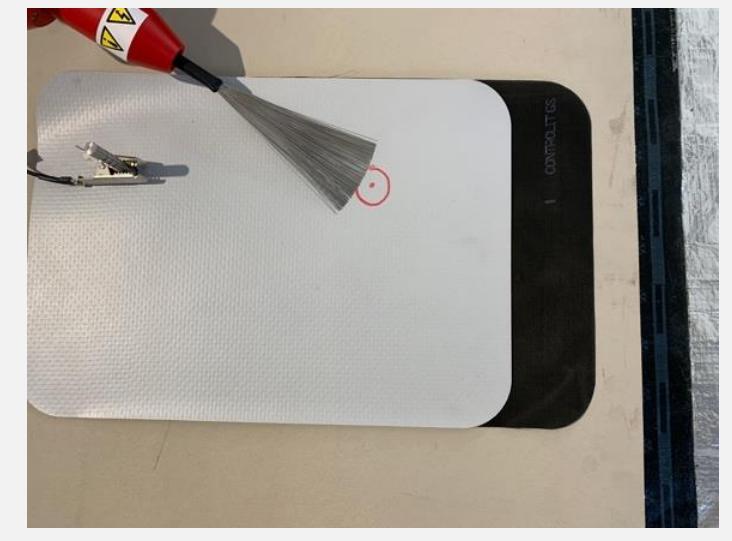
12. PIR without the electrically conductive coating and with the Controlit electrically conductive underlay

Roof structure:

- Electrically conductive bearing structure (metal or concrete).
- Bitumen vapour barrier.
- PIR thermal insulation.
- Controlit electrically conductive underlay.
- Waterproofing membrane.

Test results:

• "DRY ROOF PRO" – the pinhole was detected.

Description:

The inspection equipment was adjusted in accordance to the manufacturers instructions. The device was connected to the Controlit electrically conductive underlay through special connection points. During the inspection over the pinhole there were both visual and audible signals.

Conclusion:

It was possible to determine the damage.

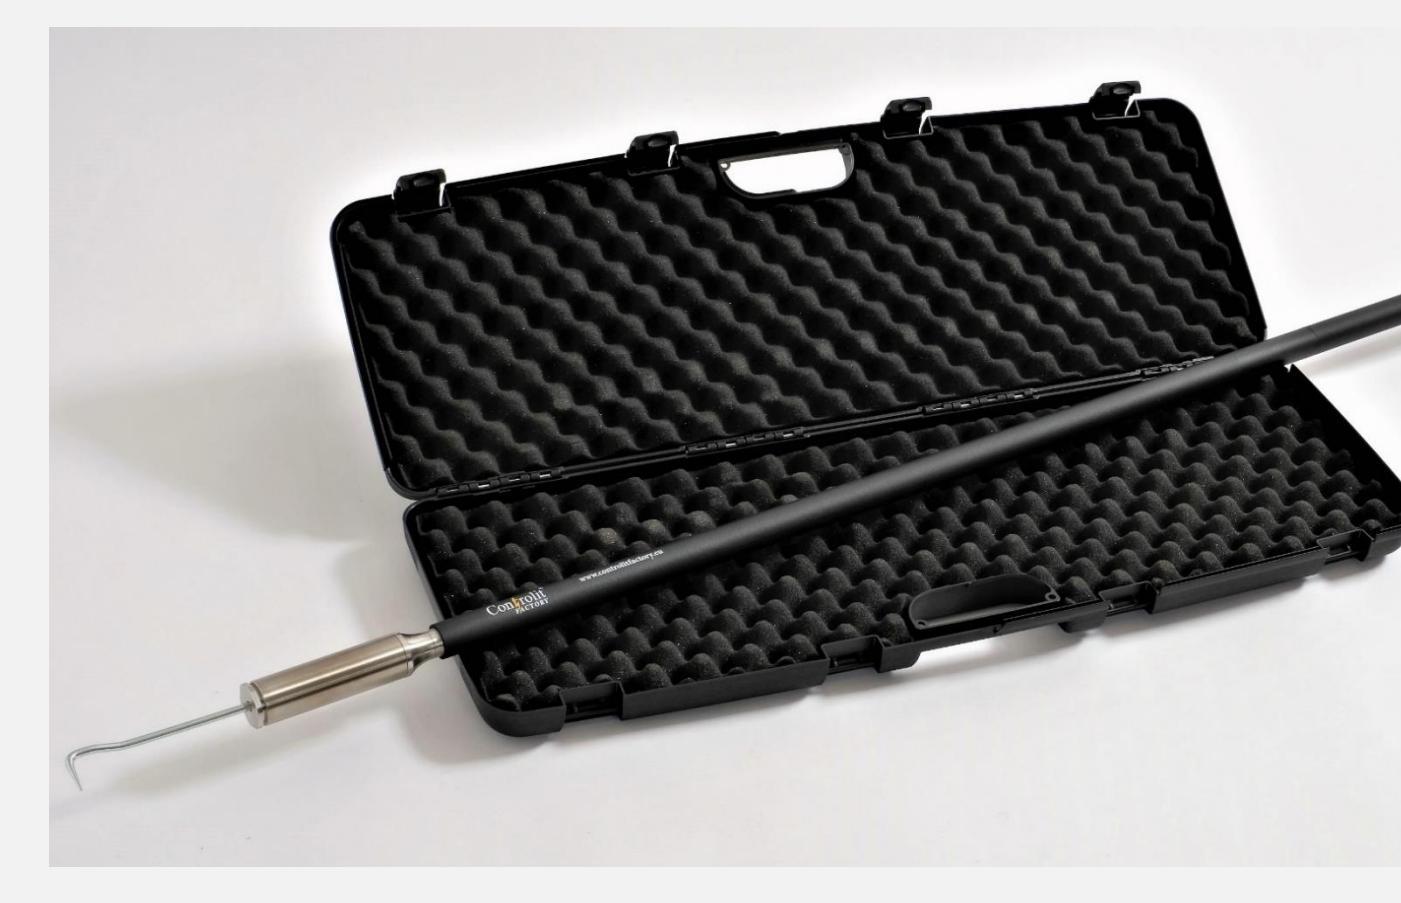
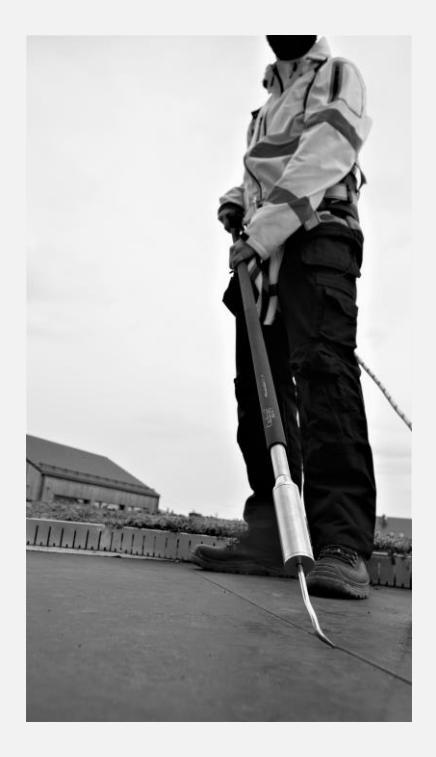
Controlit tools: extensions for curved hook

for overlap welding seams inspection

Extension for seam inspection hook with accesories for testing and checking welded seams in heat fused roofing membranes.

Product is 100% hand made from the highest quality stainless steel with high density rubber handles. Net weight: 2,155 kg Hook holder length: 160mm

Seam inspection hook extender improves seam inspection productivity up to five times.
